Manhole Inspection Summary

Manhole # S21AA1020MH

Location Address: **CLIPPER PARK RD** Cross Street: **BALMARR MEWS**

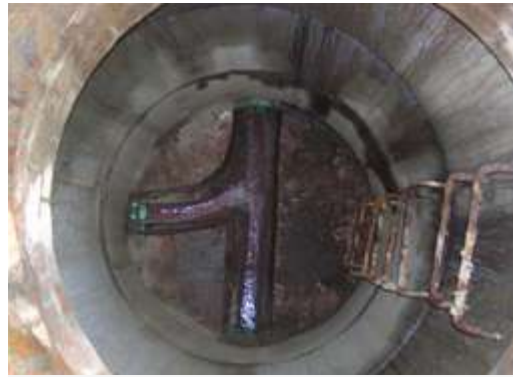
Top View

Evidence of surcharge - Bench debris.

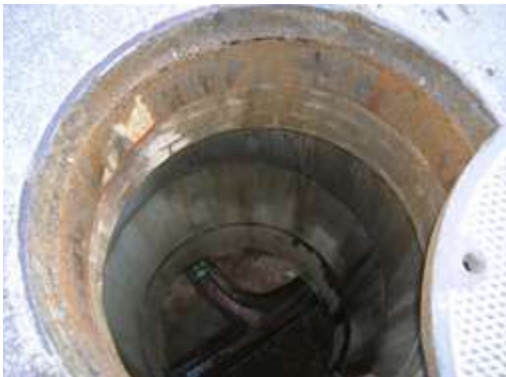
Defect

Frame Offset: **0** (in.) Condition: ☐ Sound ☐ Cracked ☒ **Leaks**

Chimney / Frame Adjustment ☒ Exists Material: **Brick** ☐ Parged Height: **9** (in.)
Condition: ☒ Sound ☐ Cracked ☐ Root Intrusion ☐ Loose Brick ☐ Deteriorated
Infiltration: ☐ None ☒ **Joint** ☐ Cracks ☒ **Mortar** ☐ Roots ☐ Wall

Frame leaks. Adjustment, Corbel and Barrel infiltration.

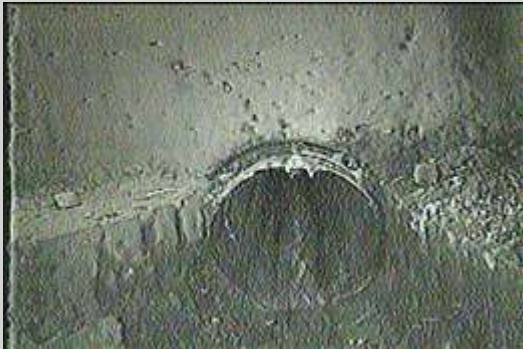
10 in. Circular Gravity Sewer Pipe Out @ 12 O'Clock

Infiltration: **Evidence** Pipe Seal Cond: **Unknown**

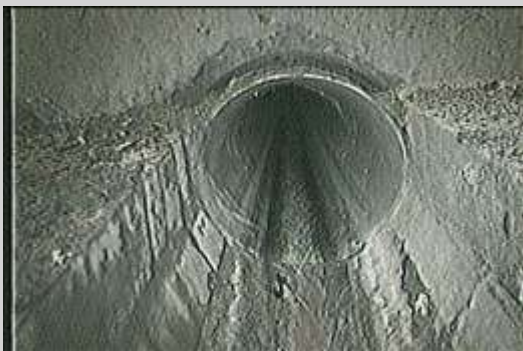
10 in. Circular Gravity Sewer Pipe In @ 6 O'Clock

Deposits: ☐ None ☒ **Mud** ☐ Sludge ☐ Debris ☒ **Grease**

Silt Depth: **0** (in.) Deposits Extent: **Light**

Infiltration: **Evidence** Pipe Seal Cond: **Unknown**

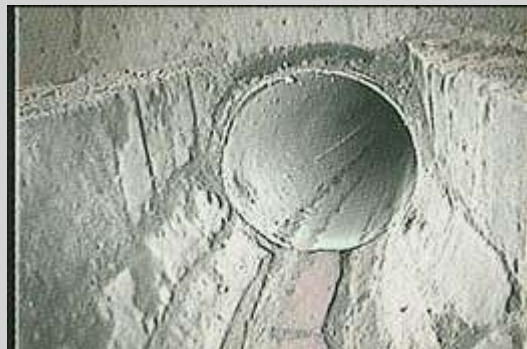
8 in. Circular Gravity Sewer

Infiltration: **Evidence**
